CONNECTICUT RIVER FLOOD CONTROL

DAM & RESERVOIR

DESIGN MEMORANDUM NO. IV

SITE GEOLOGY

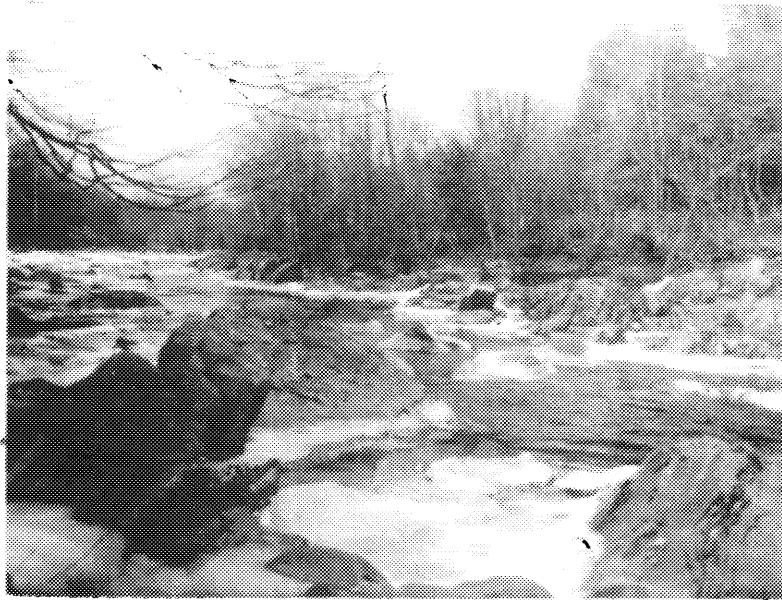
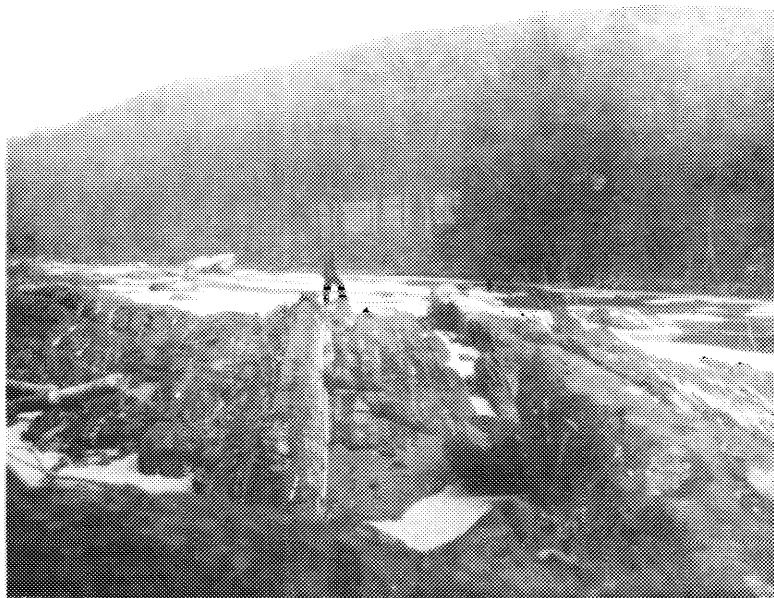
FIGURE 1

TYPICAL BEDROCK EXPOSED IN RIVER CHANNEL

LITTLEVILLE DAM SITE
